# WOOD DESTROYING PESTS AND ORGANISMS INSPECTION REPORT

| Building No.<br>3101 | Street<br>FRYMAN RD. | City<br>STUDIO CITY | Zip<br>91604 | Date of Inspection<br>10/14/26 | Number of Pages<br>7 |

| GENERAL DESCRIPTION: TWO STORY, FRAME AND STUCCO, TILE ROOF, HEADER CONSTRUCTION, ATTACHED GARAGE, SINGLE FAMILY DWELLING, FURNISHED AND OCCUPIED | Inspection Tag Posted:<br>SUBSTRUCTURE AREA<br><hr/> Other Tags Posted:<br>NONE |

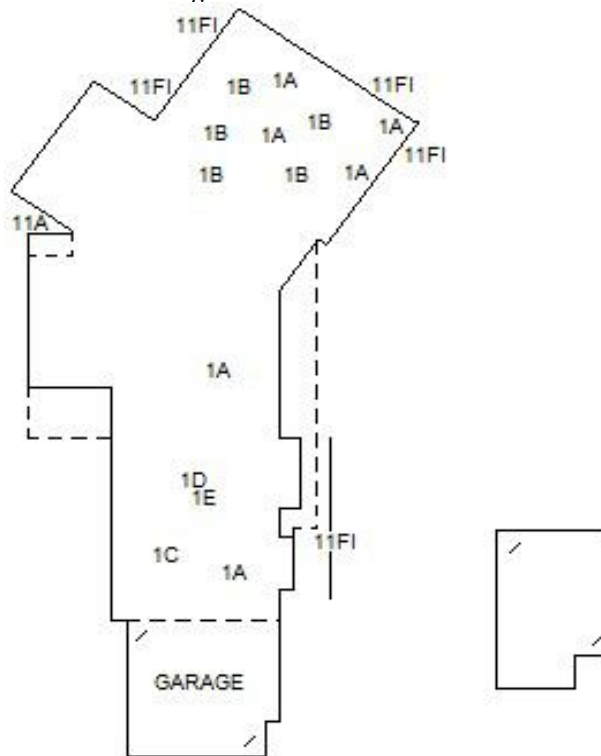
**Diagram Not To Scale**

1A:  
FINDING - Cellulose debris noted in the substructure. (SECTION II)  
RECOMMENDATION - Owner/agent should engage the services of a licensed contractor to remove all cellulose debris of a size that can be raked (or larger).

1B:  
FINDING - Evidence of earth wood contact(s) noted at post(s) in the substructure. (SECTION II)  
RECOMMENDATION - Owner/agent should engage the services of a licensed contractor to be re-grade the soil level to break the earth wood contact(s).

1C:  
FINDING - Form boards noted in the substructure. (SECTION II)  
RECOMMENDATION - Owner/agent should engage the services of a licensed contractor to be consulted and correct the above finding.

1D:  
FINDING - Evidence of a plumbing leak noted in the substructure. (SECTION II)  
RECOMMENDATION - Owner/agent should engage the services of a licensed plumber to repair plumbing leak.

1E:  
FINDING - Excessive moisture in the substructure soil. (SECTION II)  
RECOMMENDATION - Owner/agent should engage the services of a licensed contractor to be consulted and correct the above finding.

1FI:  
FINDING - Portions of the substructure are inaccessible due to ducting, insulation, piping and/or inadequate clearance (less than 12") between the bottom of the floor joists and the soil. (FURTHER INSPECTION)  
RECOMMENDATION - Owner/agent should provide access to the currently concealed area for further inspection. The area will be inspected for a fee (not to exceed the original inspection fee) if made accessible by the owner/agent at his/her expense. A supplemental report will be filed at such time. No opinion is rendered concerning the conditions in the area at this time.

FINDING - Portions of the attic is inaccessible for inspection due to ducting, insulation and/or inadequate clearance between the tops of the ceiling joists and the bottom of the rafters. (FURTHER INSPECTION)

FINDING - The wooden exterior door was warped/weather damaged at the time of this inspection. (SECTION II)

FINDING - Area(s) of the structure were concealed by heavy vegetation at the time of this inspection. (FURTHER INSPECTION)

RECOMMENDATION - Owner/agent should provide access to the currently concealed area for further inspection. The area will be inspected for a fee (not to exceed the original inspection fee) if made accessible by the owner/agent at his/her expense. A supplemental report will be filed at such time. No opinion is rendered concerning the conditions in the area at this time.

RECOMMENDATION - Owner/agent should engage the services of a licensed contractor to be consulted and correct the above finding.

RECOMMENDATION - Owner/agent should trim and/or remove vegetation to provide access to concealed areas for further inspection. The areas will be inspected for a fee if made accessible by the owner/agent at his/her expense. A supplemental report will be filed at such time. No opinion is rendered concerning the conditions of the areas at this time.
